# PRESIDENTIAL COMMISSION

*on the Space Shuttle  
Challenger Accident*

Presidential Commission  
on the  
Space Shuttle Challenger Accident

June 6, 1986

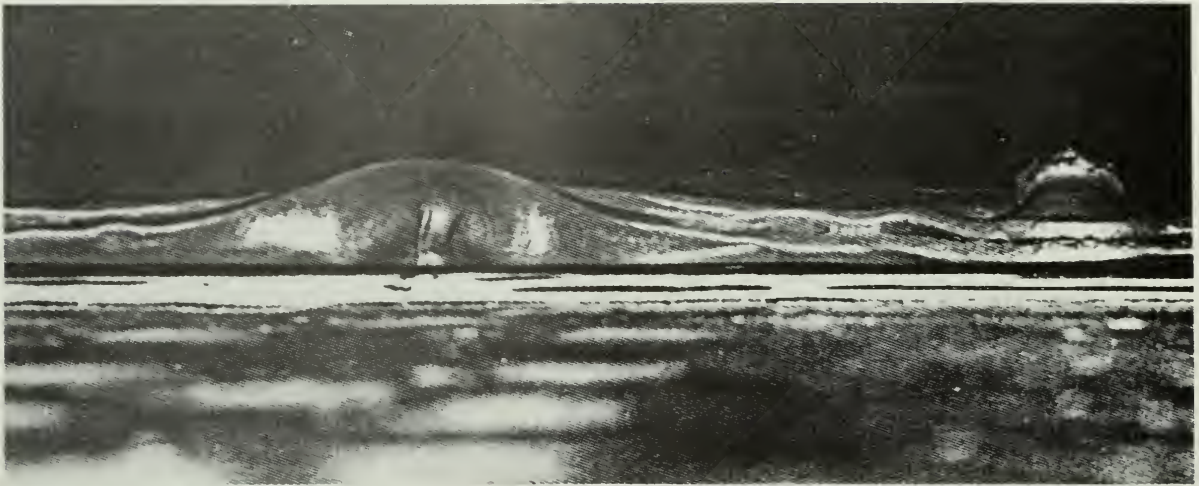
Pressure tests at 200 pounds per square inch of the Solid Rocket Booster joints produced bubbles in putty used to line the joints.
